RCRA Compliance Evaluation Inspection Report

Paulsboro Refining Company, LLC
800 Billingsport Road
Paulsboro, New Jersey 08066
EPA ID No.: NJD002342426

9:05 a.m. July 12 to 11:50 a.m. July 14, 2016

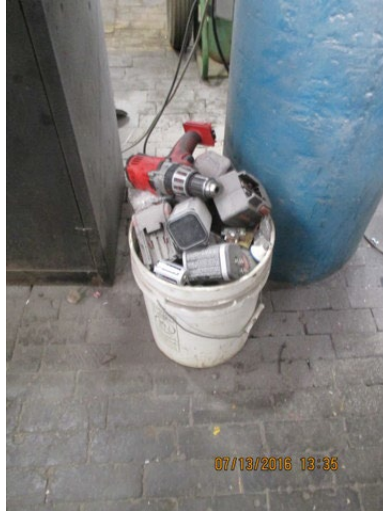
PBF operates one main maintenance shop. The shop uses parts washers which Safety Kleen services on a roughly monthly basis. Spent solvents typically go offsite with waste codes D027, D039, D040 and F005. The shop also has a satellite accumulation area (SAA) for aerosol cans and rags. The inspection team observed one unlabeled bucket in the shop with batteries, including alkaline, lithium and nickel cadmium batteries (see Photo 1).

Photo 1. Unlabeled 5-gallon Bucket Containing Used Alkaline, Lithium Ion, and Other Batteries

An unlabeled bucket in the machine shop contained waste alkaline, lithium, and nickel cadmium batteries.

Universal waste batteries must be labeled or marked clearly with any one of the following phrases: “Universal Waste – Batteries”, “Waste Batteries”, or “Used Batteries. Regulatory Citation: 40 CFR 273.14(a).

The date the first battery is generated must be recorded on the buckets to verify that the used batteries do not remain in storage for more than one year. Regulatory Citation: 40 CFR 273.15©.

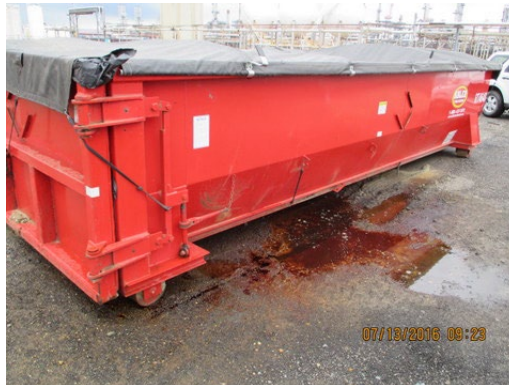
PBF has various equipment and material laydown yards around the refinery for staging and storage purposes. During a visit to the construction and demolition laydown yard, the inspection team identified liquid with an oily sheen beneath a roll-off container full of laboratory sample containers and various other debris (see Photos 2 and 3).

Photo 2. Oily Sheen Beneath Roll-off Bin in Construction and Demolition Laydown Yard

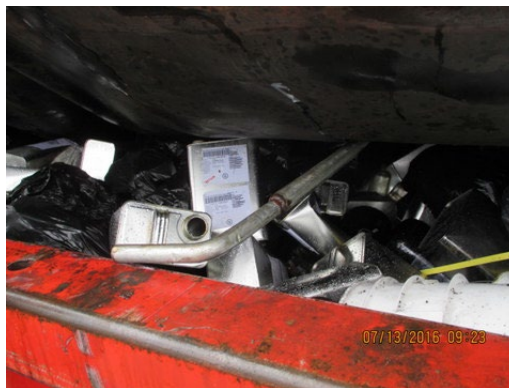
Photo 3. Contents of the Roll-off Bin in the Construction and Demolition Laydown Yard (Visible Label Says Diesel)

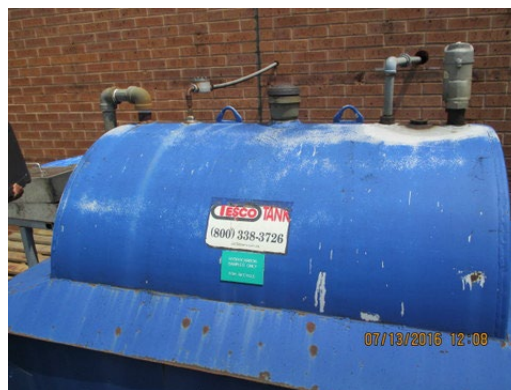
Photo 4. Laboratory Slop Oil Tank (Label Reads "Hydrocarbon Samples Only for Recycle")

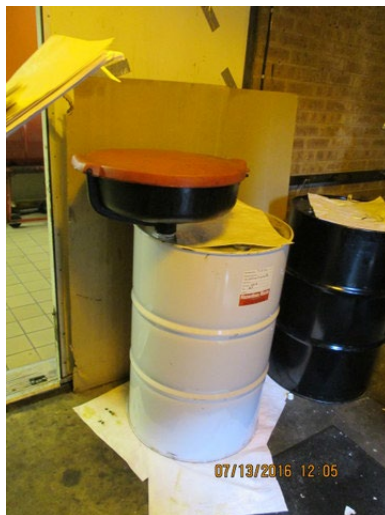
Photo 5. Hazardous Waste Barrel in Laboratory's 90-Day Area (Label Reads "Solvent Waste", "7-11-16")

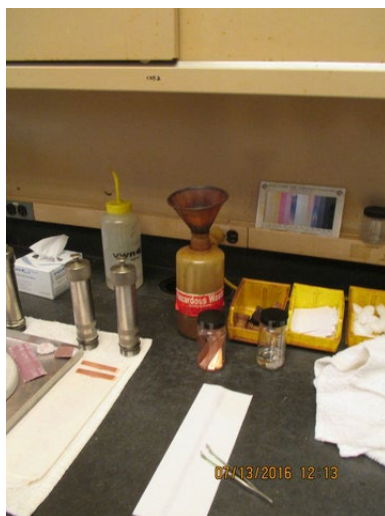
The inspection team observed an open container on the lab's second floor labeled hazardous waste that had a funnel in it (see Photo 6). Prior to the inspection closeout, Mr. Eric Campbell, the laboratory manager, noted that the material in the container is hydrocarbon material destined for recycling and is not, therefore, a hazardous waste.

Photo 6. Open, Partially Full Container in Laboratory Labeled "Hazardous Waste"

- Open container in the lab labeled hazardous waste, which was being recycled through the slop oil tank.
- The side of the TBA warehouse used to store products was disorganized, had several containers in poor condition, and had standing water with an oil sheen on the floor in some areas.

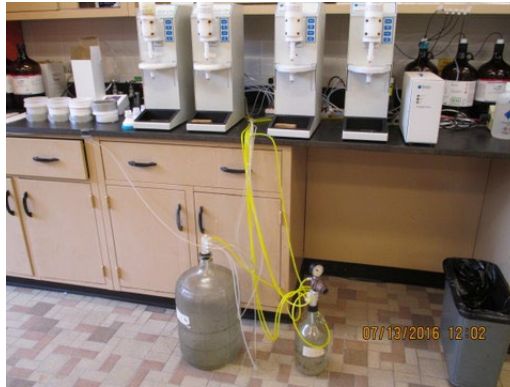
The inspection team also observed a bottle on the floor receiving solvent waste from an analytical instrument with no label and several inches of fluid (see Photo 7).

Photo 7. Two Hazardous Waste Containers in Laboratory with Illegible Labels (Faded and Worn)

A container in the laboratory receiving hazardous waste solvent from an analyzer did not have a legible label.

Each container should be labeled “Hazardous Waste” or with other words that identify the contents. Regulatory Citation: 40 CFR 262.34©(1)(ii).

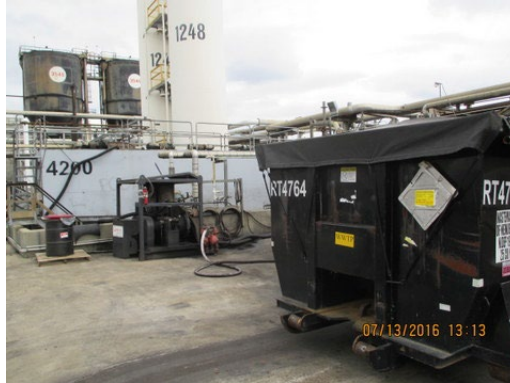
The API separator separates wastewater treatment plant influent into solids, water, and oil. Oil skimmed from the wastewater at the API separator goes to recovered oil tanks, that return the oil to the refinery's processes via the slop oil tanks. Solids go to a "Blue Monster" container for recycling into the coker. The solids are staged in a roll-off bin adjacent to the coker (see Photo 8). Roll-off bins that are emptied into the "Blue Monster" container are returned to the WWTP and other process areas with RCRA clean labels.

Photo 8. Staging Area for Sludge Fed into Coker (Labels Say “WWTP”, “Blue Monster”, “Hazardous Secondary Material”, and “7-13-2016”)

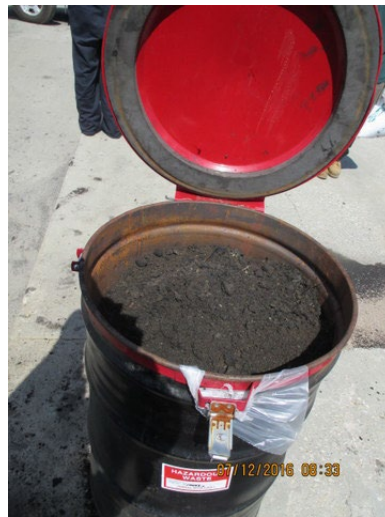
The distillation pad is an offloading point to the WWTP for oily liquids hauled by vacuum trucks. The origin of the name of the area was unknown to facility staff – there is no active distillation process there now. The offloading point includes a sump with a filter for screening debris from the oily liquids, and a hazardous waste drum for consolidation of the debris (see Photos 12 and 13). At the time of the inspection, there was also a flow bin filled with slop oil staged near the offloading point (see Photo 14).

Photo 12. Debris from Vacuum Truck Offloading Point at Distillation Separator Pad

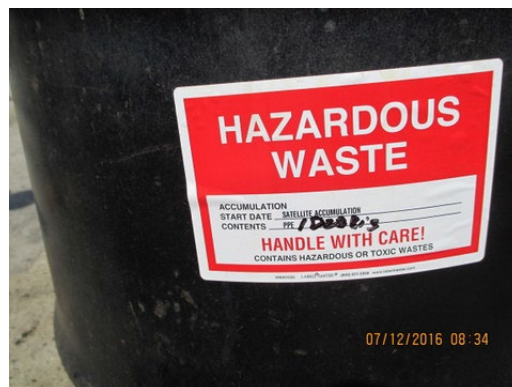
Photo 13. Debris from Distillation Separator Pad (Close-up View of the Label)

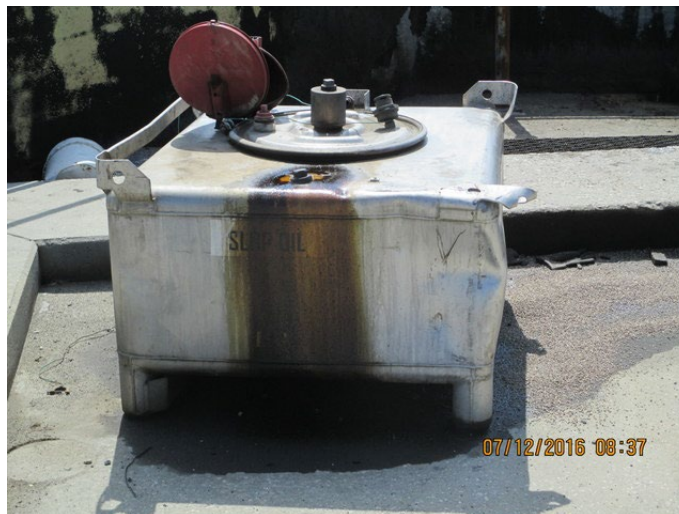
Photo 14. Flow Bin Labeled “Slop Oil” Staged at Distillation Separator Pad

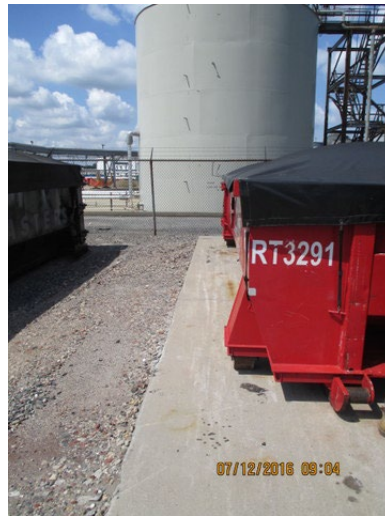
Photo 17. Edge of Concrete at Braun Pad

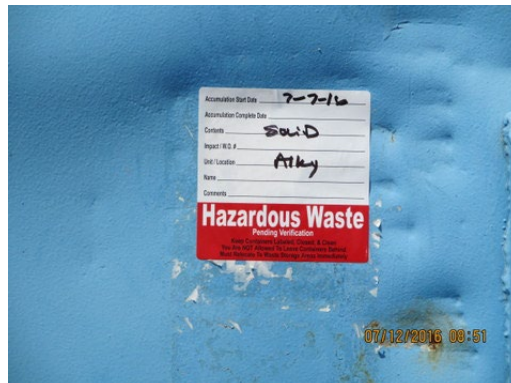
The inspection team noted several containers which said “Pending Analysis” where staff had already made a hazardous waste determination, and several labels also had vague descriptions of the waste contents (see Photo 18). Mr. Johnson noted that containers are not typically relabeled until they are shipped offsite. The inspection team also noted two roll-off bins that had torn covers (see Photos 19 and 20).

Photo 18. Roll-off Bin Containing “Alkyl” Hazardous Waste in the Braun Pad

- Hazardous waste labels read “Pending Analysis” even where the analysis had already been completed. Some labels also had only very vague information such as “Haz” or “Solid” in the contents field.

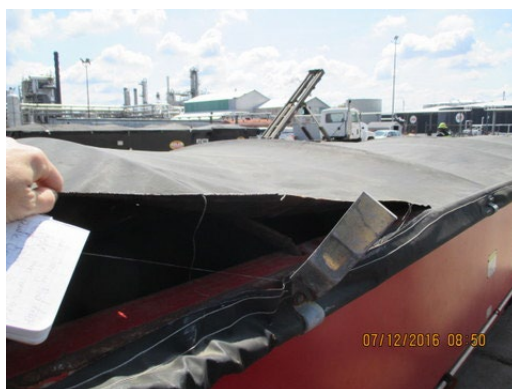
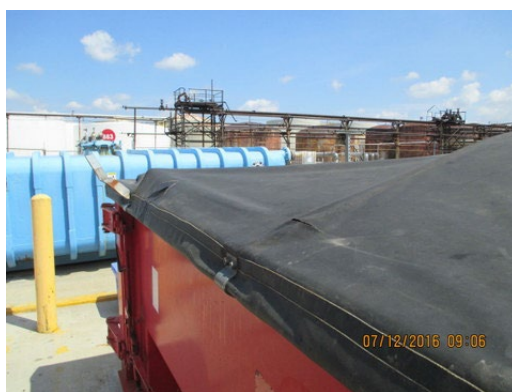
Photo 19. Torn Lid on First Roll-off Bin Containing Hazardous Waste in the Braun Pad

Photo 20. Torn Lid on Second Roll-off Bin Containing Hazardous Waste in the Braun Pad

Two roll-off bins in the Braun Pad had torn covers.

Containers holding hazardous waste should be closed unless material is being added and should be in good condition. Regulatory Citation: 40 CFR 264.171 and 264.173a.

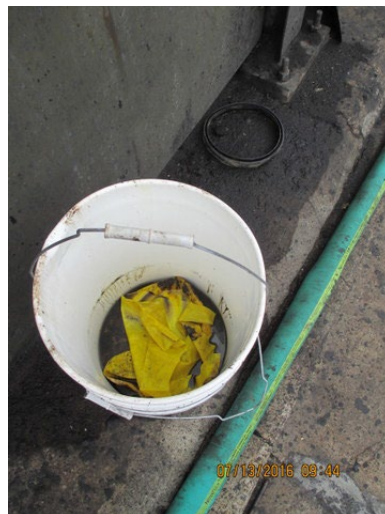
During the visit to the bundle cleaning pad, the inspection team observed what appeared to be used PPE in an unlabeled 5-gallon bucket (see Photo 29), and used PPE on the ground and in an open, unlabeled garbage bag (see Photos 30 and 31). The inspection team also observed various discarded materials, sludge, and water, in an unlabeled metal bin on the bundle cleaning pad (see Photo 32).

Photo 29. Yellow Plastic Fabric and Sludge in Unlabeled 5-gallon at Bundle Cleaning Pad

Used PPE at the bundle cleaning pad was not in proper, labeled containers.

Each container should be labeled “Hazardous Waste” or with other words that identify the contents. Regulatory Citation: 40 CFR 262.34©(1)(ii).

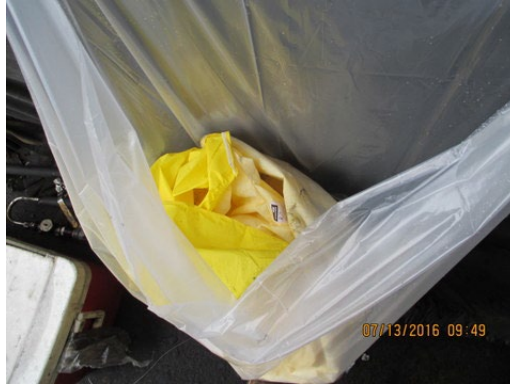
Photo 30. Soiled PPE in Unlabeled, Open Garbage Bag at Bundle Cleaning Pad

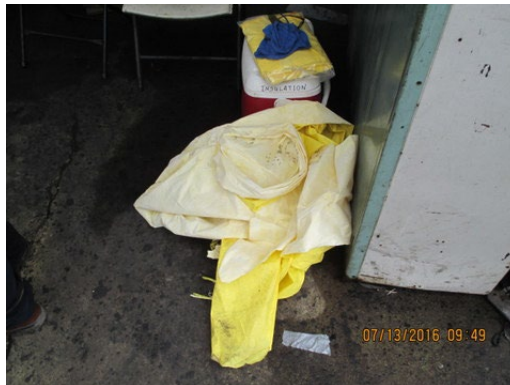
Photo 31. Soiled PPE on Ground at Bundle Cleaning Pad

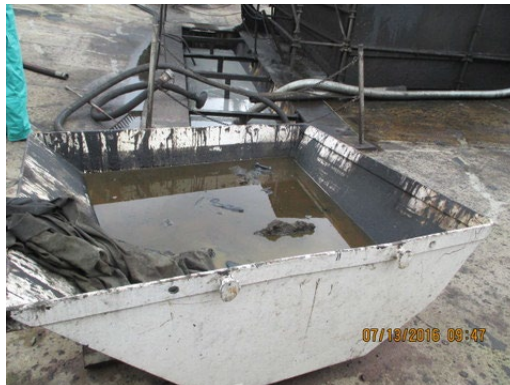
Photo 32. Sludge, Water, Hardware, and Black Silt Fence Fabric in Unlabeled Bin at Bundle Cleaning Pad

- A metal container on the bundle cleaning pad was unlabeled but contained sludge, water, hardware, and other debris. Facility staff investigated and determined that the material was actually asphalt that had been discarded from an asphalt truck.
- Water with an oily sheen was present under a roll-off bin in the Construction and Demolition Laydown yard. The roll-off bin contained RCRA empty one-gallon tin containers for process sampling and other miscellaneous materials.
- The weekly inspection form from June 26, 2016, for the TBA warehouse was not filled out properly.
- Eyewash station in TBA Warehouse is a self-contained unit which does not records indicating the date on which the eyewash fluid is replaced. Facility staff indicated the eyewash fluid is replaced two times per year but no records are being maintained.
